# Intergranular Corrosion-Fatigue Failure of Cobalt-Alloy Femoral Stems

A FAILURE ANALYSIS OF TWO IMPLANTS\*

BY JEREMY L. GILBERT, PH.D.†, CHRISTINE A. BUCKLEY, M.S.‡, JOSHUA J. JACOBS, M.D.‡, KIM C. BERTIN, M.D.§,  
AND MICHAEL R. ZERNICH, M.D.¶, CHICAGO, ILLINOIS

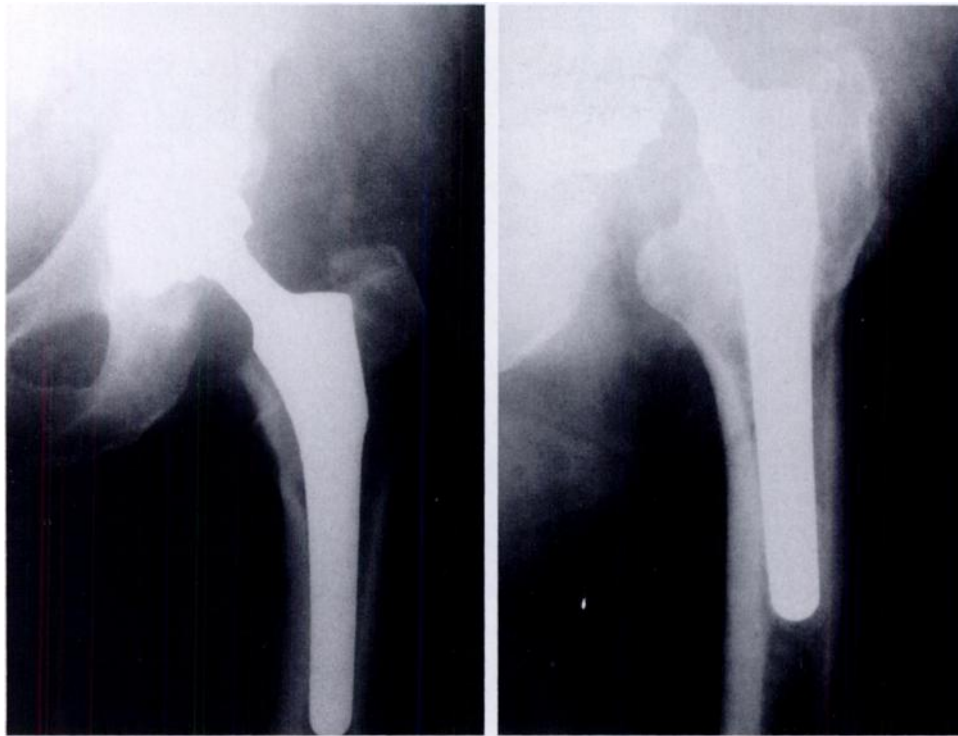
**CASE 1.** A 112-kilogram, 175-centimeter-tall man had a primary total hip replacement with the insertion of a PCA prosthesis (Howmedica, Rutherford, New Jersey) without cement, at the age of sixty-seven years, for the treatment of severe osteoarthritis (Fig. 1-A). Seventy months postoperatively, the patient was seen by one of us (M. R. Z.) because of the sudden onset of pain in the hip. Before this, the hip had been asymptomatic. The patient had had an active lifestyle and had frequently played golf. Radiographs revealed a fractured prosthetic neck (Fig. 1-B).

Figs. 1-A and 1-B: Case 1. Clinical anteroposterior radiographs.

Fig. 1-A: Postoperative radiograph.

Fig. 1-B: Seventy months postoperatively, the fractured prosthetic neck is clearly seen just distal to the head-neck junction.

At the revision, the prosthetic fracture was easily identified, and the prosthetic head was free in the joint. The femoral component was extremely well fixed to the adjacent bone and was difficult to extract. On removal, an extensive amount of bone was adherent to the device, and a fracture of the femoral shaft was sustained intraoperatively. The acetabular component was well fixed. A long-stem prosthesis was inserted without cement and with the use of strut allografts. The patient was doing well two years postoperatively.

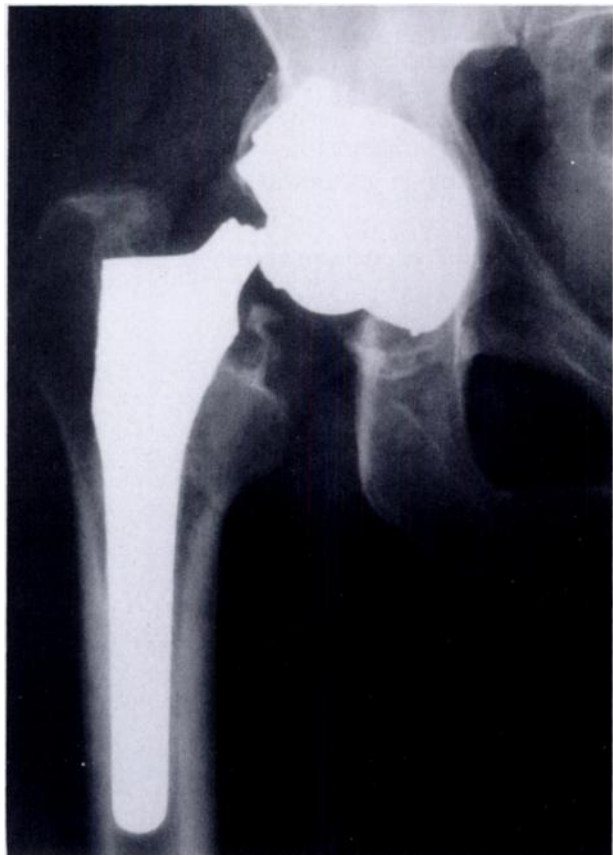
FIG. 2

Eighty-five months postoperatively, the patient was seen in the emergency room by one of us (K. C. B.), because of an acute onset of severe pain in the right hip and an inability to bear weight on the right lower extremity. Just before the onset of the pain, the patient had noted a loud snap when he was bending over while mowing his lawn. He stated that for three weeks before this incident the pain in the thigh had been slightly worse. He recalled no specific traumatic event leading to the current, acute symptoms. Radiographs revealed a fractured prosthetic femoral neck (Fig. 2).

Case 2. Clinical anteroposterior radiograph showing the fractured prosthesis eighty-five months postoperatively.

At the revision, the fracture of the femoral component was readily identified. There was chronic granulomatous tissue within the joint capsule, but there was no evidence of metallic tissue-staining. The femoral component was well fixed and difficult to extract. The acetabular component was also well fixed, but, because of substantial polyethylene wear, it was also removed. A revision total hip replacement was done without cement. The patient was minimally symptomatic seven months postoperatively.

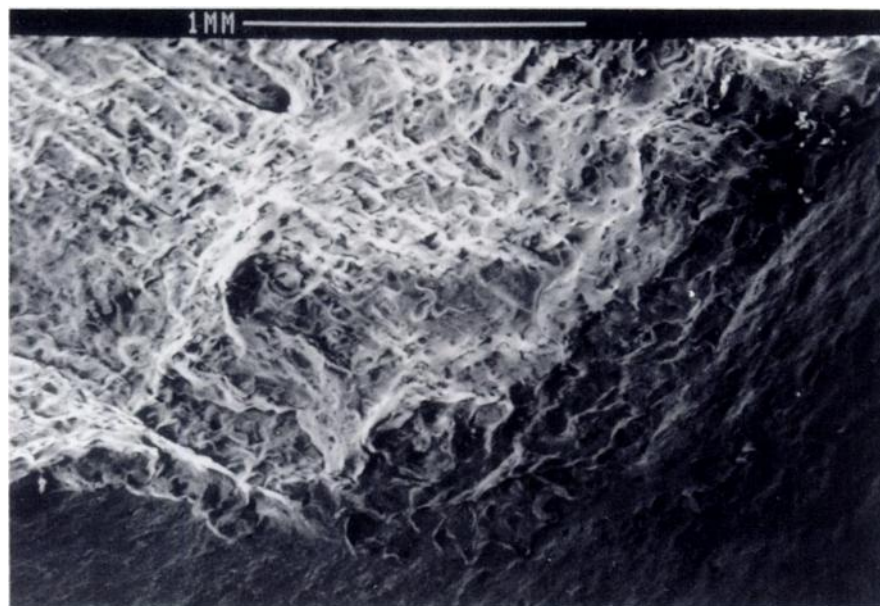
FIG. 3

Case 1. Low-magnification micrograph of the edge of the fracture surface, showing the intergranular nature of the fracture. The fracture surface at the superior initiation point is at the upper left, and the free surface of the neck is at the lower right. Intergranular pores are present on the fracture surface ( $\times 41.8$ ).

For Case 1, a low-magnification scanning electron micrograph of the superolateral fracture surface (Fig. 3) showed that the fracture surface had a smooth appearance, with small pores or craters. As will be subsequently shown, this appearance was due to interconnected and isolated porosity as well as a corrosive attack at the

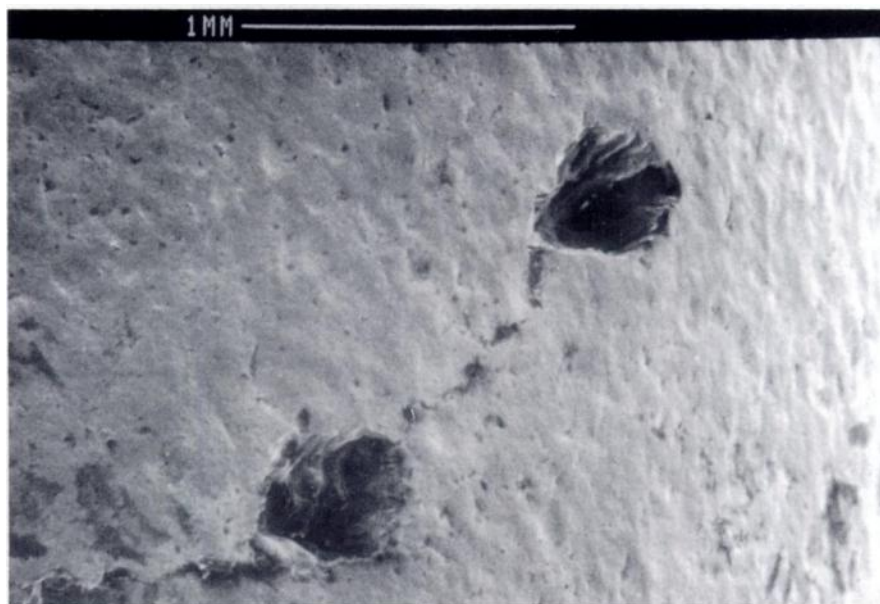
FIG. 4

Case 1. Low-magnification micrograph of the free surface, showing pits that have formed because of egression of small surface grains. These small grains are located at the larger grain boundaries ( $\times 40.8$ ).

Intergranular cracks were seen to connect several pits that had formed on the outer surface of the prosthesis (Fig. 4). These pits, which were as large as 500 micrometers in diameter, were small surface grains that had fractured about their boundaries and had egressed out of the surface microstructure. These small egressed grains were typically located at the larger-grain boundaries.

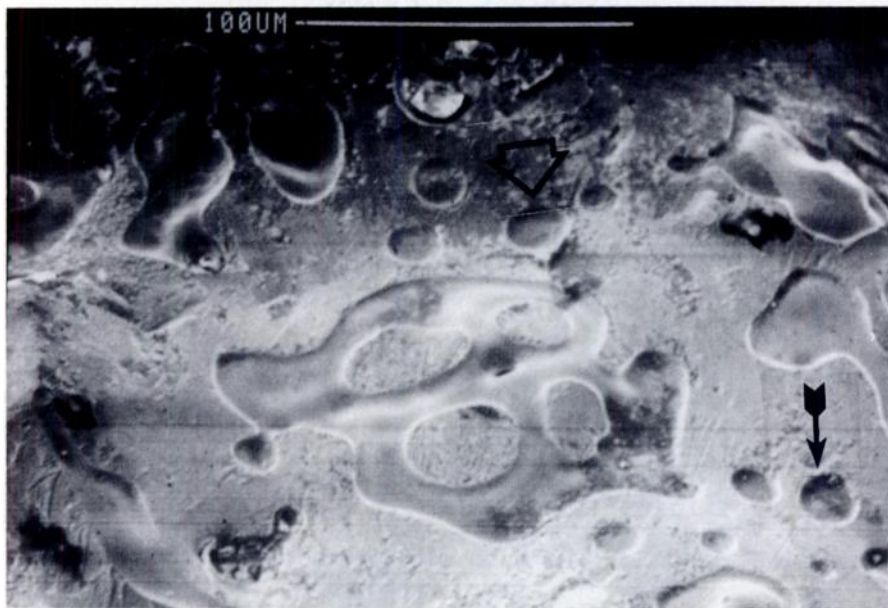
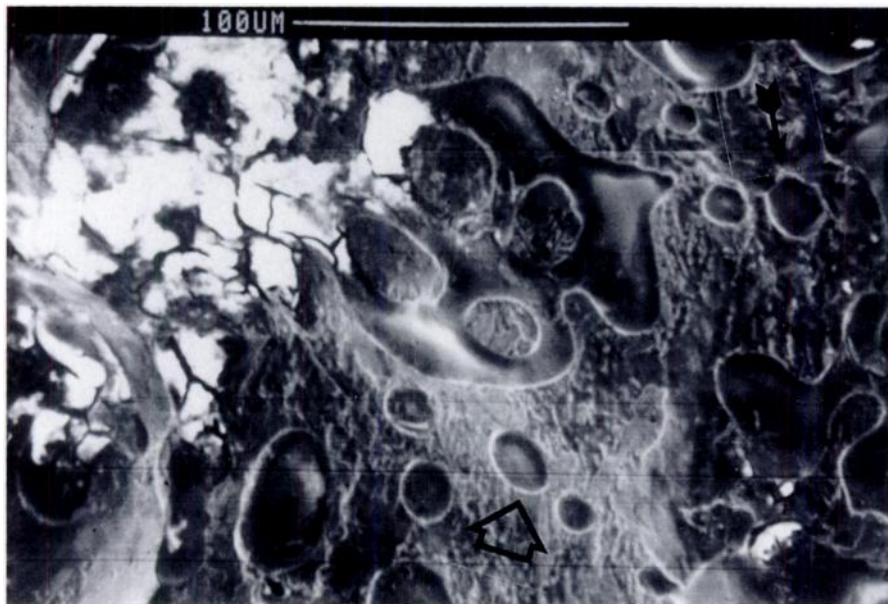
Figs. 5-A and 5-B: Case 2. Micrographs of the opposing fracture surfaces, showing the smooth and rough regions. Note the mirror symmetry, from top to bottom, of the two figures. The pores (arrows) appear to be isolated by the rough regions, indicating that they were present before the fracture of the prosthesis. Some non-conducting debris, which is rich in chromium and most likely consists of segregated carbides at the grain boundaries, can be seen (Fig. 5-B, upper left) ( $\times 406$  [Fig. 5-A] and  $\times 400$  [Fig. 5-B]).

The appearances of the fracture surfaces were similar for the two retrieved implants. Micrographs of Case 2 (Figs. 5-A and 5-B), made about one millimeter from

the lateral free surface (that is, at the site at which the fracture had initiated), showed two general regions of interest: one smooth and one rough. The rough regions appeared to be deformed, to show clear evidence of pitting corrosion attack, and to indicate that the grain boundaries in these regions were initially intact but had subsequently been attacked by the combined effects of the repeated cyclic loading and the intergranularly penetrating fluid. The smooth regions appeared to be slightly depressed from the rough regions and were irregular in shape. These smooth regions may have been due either to an initial intergranular corrosive attack,

This analysis was carried out for Case 2. Micrographs with mirror symmetry, from top to bottom, of the same region on opposing fracture surfaces (Figs. 5-A and 5-B) showed several isolated, roughly circular pores that had no signs of being interconnected but were, instead, only surrounded by a rough fracture surface.

This suggests that the pores were not created by fluid penetrating along the grain boundaries but were instead generated during the manufacture of the prosthesis.

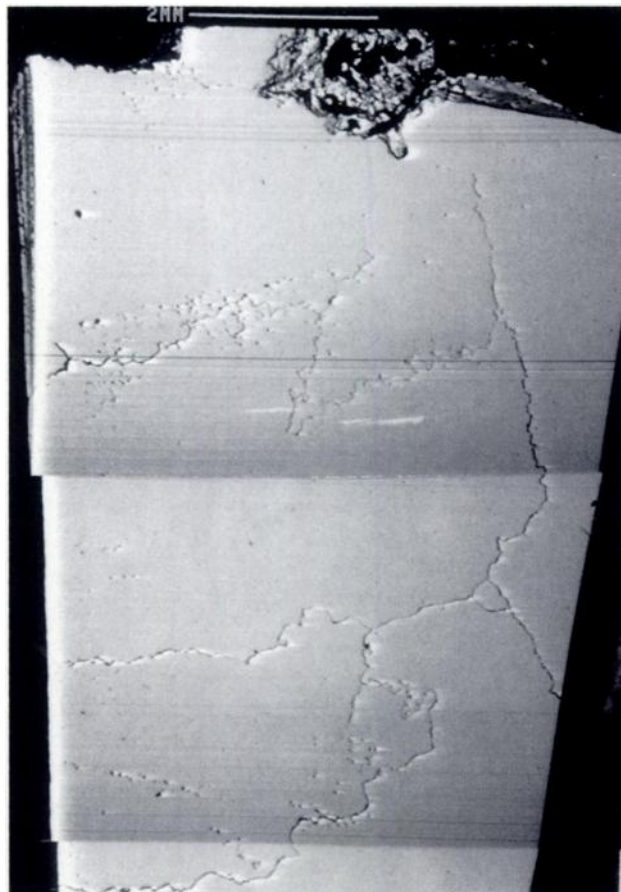
FIG. 6

Case 1. Montage of the cross section, with the fracture surface at the top and the laterosuperior surface at the left, showing intergranular cracks throughout the neck. The fracture surface follows the grain boundaries of the material.

The sections from the necks revealed clear evidence of corrosive penetration of fluid intergranularly into the microstructure. This intergranular attack was adjacent to the fracture surface and was continuous with an intergranular attack emanating from the head-neck taper region. In a montage of a sectioned surface from Case 1 (Fig. 6), the outline of the grains was seen clearly and was the result of intergranular attack and porosity. For Case 2, the neck-head taper junction was seen clearly and had been extensively attacked at the grain bound-

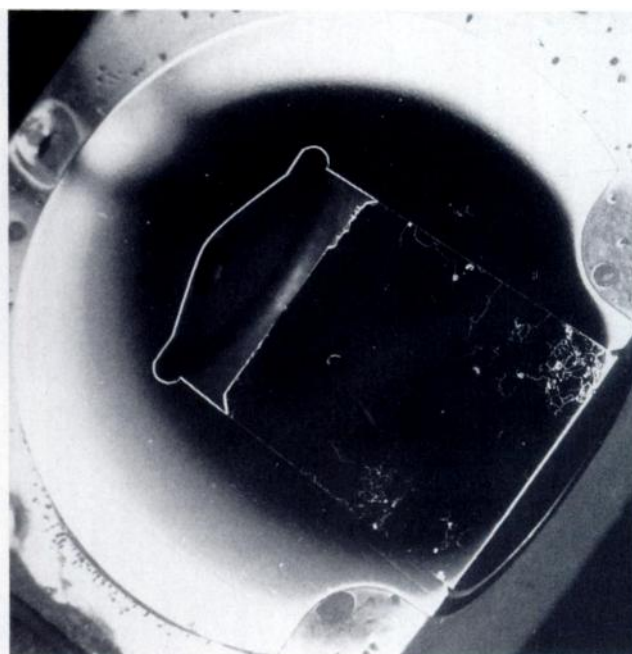
FIG. 7

Case 2. Optical photograph showing intergranular cracking at the taper-free surface junction. This cracking, which is localized at the taper junction, appears to travel down into the neck toward the region of the fracture surface.

aries (Fig. 7). The intergranular attack seemed to be concentrated at the superior and inferior surfaces of the neck at the taper-free surface junction.

Furthermore, an intergranular corrosive attack was shown to have occurred in the neck region, at the lateral and medial sites of the head-neck taper junction, and this intergranular attack had penetrated several millimeters into the microstructure. In Case 2, the intergranular cracking was focused at the taper junction and had penetrated into the microstructure.
