The Fall and Rise of “Owl”

Robert Oddy

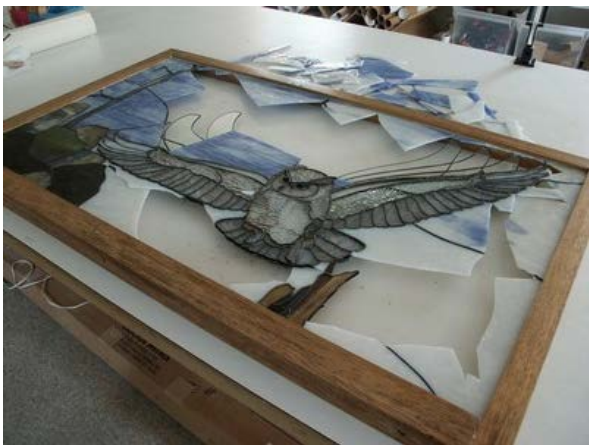
Figure 2: Broken Owl

Before I could undertake the repair work, I had to lay the pitiable wreck on the bench (figure 2) and examine every square inch for cracks. In addition to the very obvious state of the sky, much of which had fallen out of the window, several pieces in the rocks and tree on the left-hand side were cracked, the craggy stump at the bottom was ruined, and about twenty pieces in the bird's wings and body were broken. Some were not immediately obvious because they were in the lower layers. In all, about 25% of the original glass pieces would have to be replaced, accounting for about 80% of the total area of glass.

The first question I had to answer was whether I should repair the window or make it again from scratch. I decided that enough of the intricate and therefore time-consuming work in the owl itself had survived that the window was worth repairing. I made an estimate of the new glass needed and the time for the job, which was rather approximate because I do not usually undertake repair work unless the piece is one of my own. I quoted a cost to the owner, and the repair work was approved.

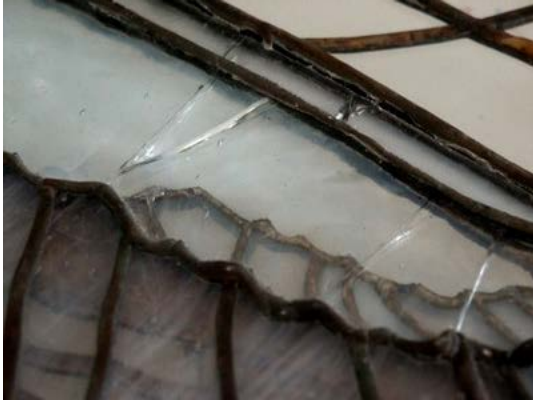
Figure 8: Some cracks in plated wing

This meant that the glass layers were not interlocked where the wings met the body, and the solder joining them did not penetrate beyond the surface. I examined the sections carefully for cracks, to determine which plates would need to be separated (figure 8). In this case, they all needed to be separated. I melted off as much as possible of the old solder from the edges of the plated section (holding the section vertically), then looked for a place where I could insert a thin blade between the layers as a wedge. Gently twisting the blade to provide outward pressure, I melted the solder close to the blade to widen and lengthen the gap (figure 9).

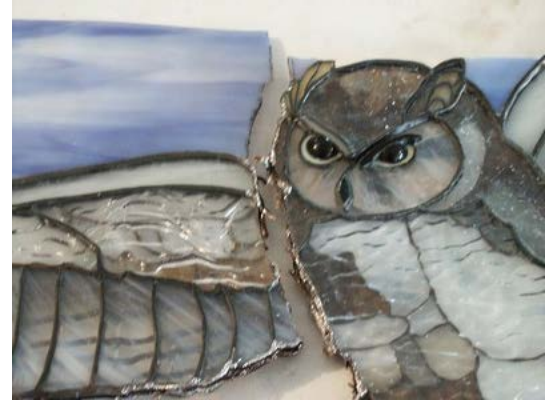
Figure 7: Wing separated from body
(Note: Blue glass is easier to remove from corners after taking off wings...)

The wings and body of the owl are all plated—three layers of glass in some places—and separating plated sections can be difficult. I first separated the wings from the body (figure 7). This turned out not to be too difficult, because I had originally made them separately and then joined them together as whole units.
