The fall and rise of "Owl"

The Fall and Rise of “Owl”

Robert Oddy

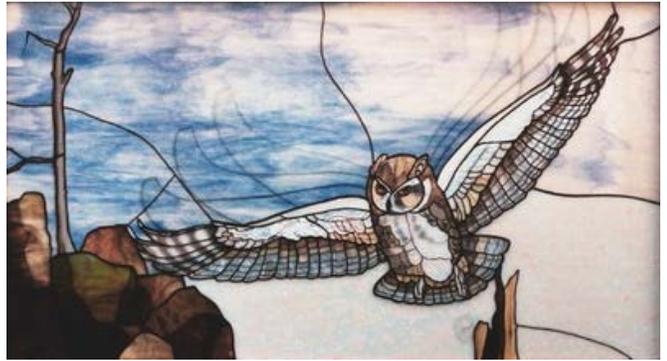
Figure 1: Owl (1988) 22" x 39" stained glass

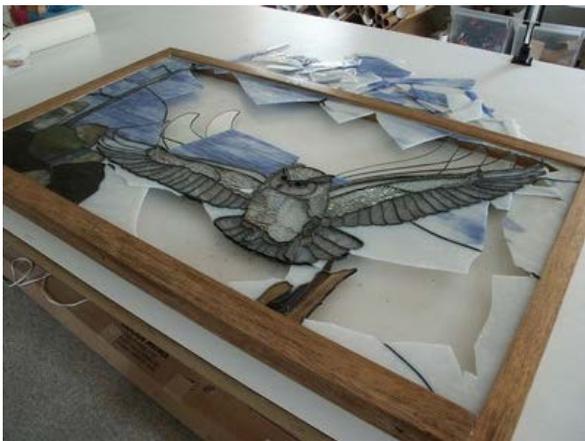
Figure 2: Broken Owl

Before I could undertake the repair work, I had to lay the pitiable wreck on the bench (figure 2) and examine every square inch for cracks. In addition to the very obvious state of the sky, much of which had fallen out of the window, several pieces in the rocks and tree on the left-hand side were cracked, the craggy stump at the bottom was ruined, and about twenty pieces in the bird's wings and body were broken. Some were not immediately obvious because they were in the lower layers. In all, about 25% of the original glass pieces would have to be replaced, accounting for about 80% of the total area of glass.

The first question I had to answer was whether I should repair the window or make it again from scratch. I decided that enough of the intricate and therefore time-consuming work in the owl itself had survived that the window was worth repairing. I made an estimate of the new glass needed and the time for the job, which was rather approximate because I do not usually undertake repair work unless the piece is one of my own. I quoted a cost to the owner, and the repair work was approved.

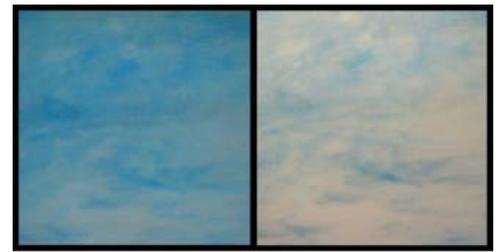
Figure 3: Glass for the sky in daylight (left) and in white fluorescent light (right)

Some of the opalescent glass, particularly in the sky, proved difficult to find. The glass I used in the original in 1988 was not newly manufactured even at that time. One factor in the choice of a replacement was that the window was destined to be installed in a light box, rather than in an exterior window, as it had originally been. I found a satisfactory substitute in a sky-blue and white opalescent by Kokomo. You can see in (figure 3) that this glass is much bluer in daylight. The whites are more prominent, and a little more yellow in white fluorescent light, more like the original glass appeared in daylight. Some of the glass in the rocks, tree and stump is also different from the original. I had no problem finding glass from stock in my studio to match the original glass in the owl's wings and body.

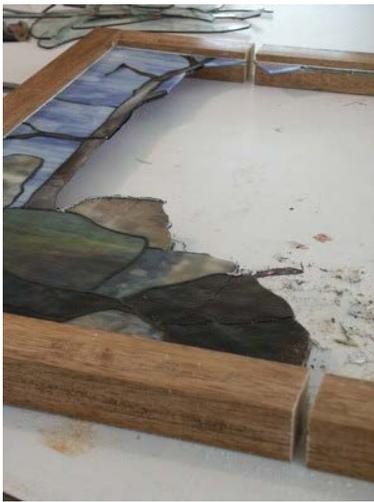
Figure 4: Old frame cut into pieces

The first task was to remove the glass from the frame. The old frame was made to fit the window opening in the original site and would not be needed for the new installation in a light box. The easiest way to remove glass that I wished to salvage was to cut up the frame (figures 4 & 5). I then separated the owl from most of the surrounding glass.

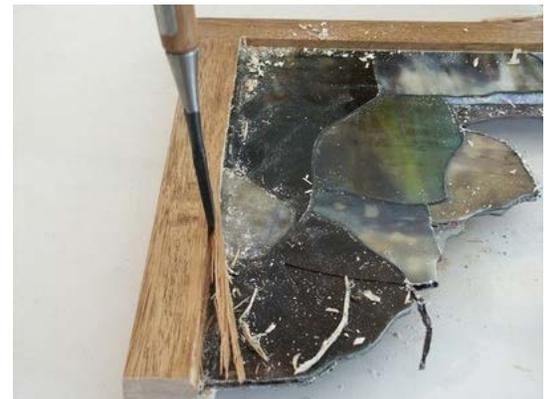
Figure 5: Wood removed to release glass

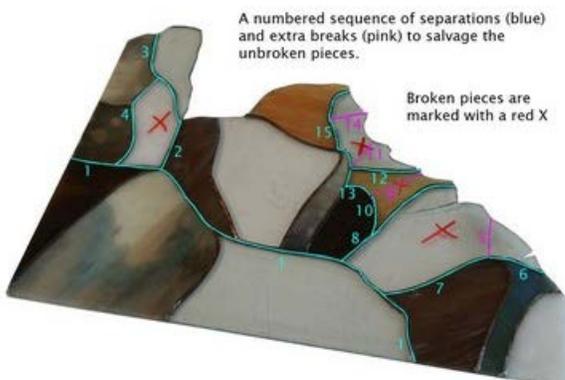
Figure 6: Separation lines for a damaged section

Sometimes I first separated undamaged pieces, and sometimes I made extra breaks in already cracked pieces to make the separation easier (figure 6).

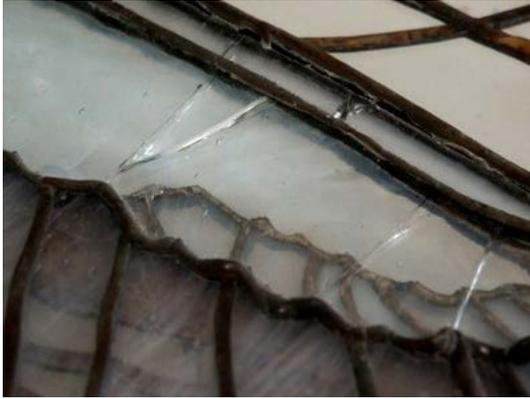
Figure 8: Some cracks in plated wing

This meant that the glass layers were not interlocked where the wings met the body, and the solder joining them did not penetrate beyond the surface. I examined the sections carefully for cracks, to determine which plates would need to be separated (figure 8). In this case, they all needed to be separated. I melted off as much as possible of the old solder from the edges of the plated section (holding the section vertically), then looked for a place where I could insert a thin blade between the layers as a wedge. Gently twisting the blade to provide outward pressure, I melted the solder close to the blade to widen and lengthen the gap (figure 9).

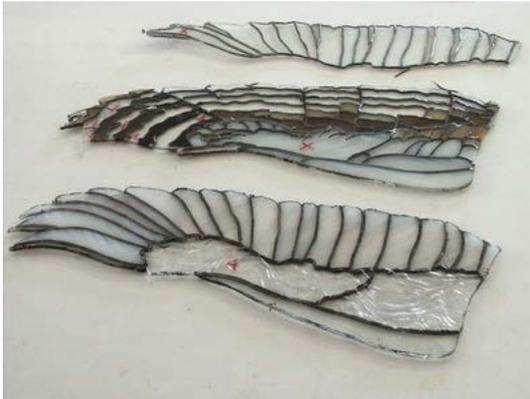
Figure 10: Three layers of a wing separated

Working this way all around the plated section, eventually the layers came apart (figure 10). More important than skill is patience!

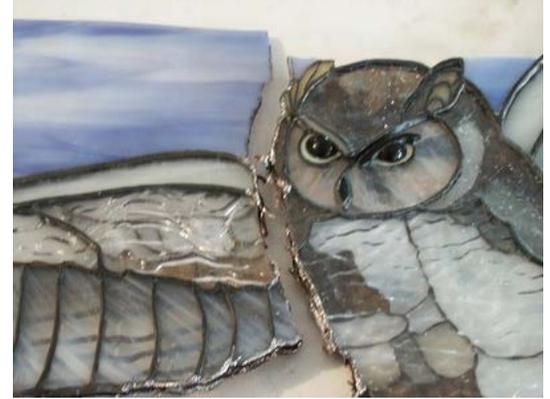
Figure 7: Wing separated from body
(Note: Blue glass is easier to remove from corners after taking off wings...)

The wings and body of the owl are all plated—three layers of glass in some places—and separating plated sections can be difficult. I first separated the wings from the body (figure 7). This turned out not to be too difficult, because I had originally made them separately and then joined them together as whole units.

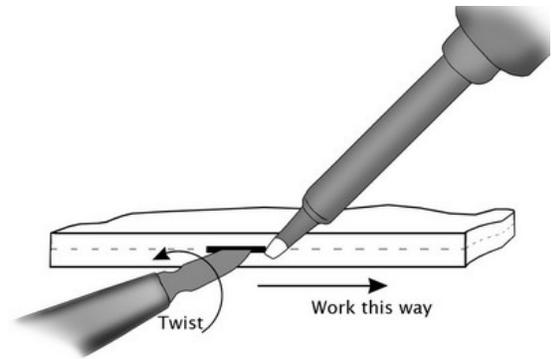
Figure 9: Prizing plated layers apart

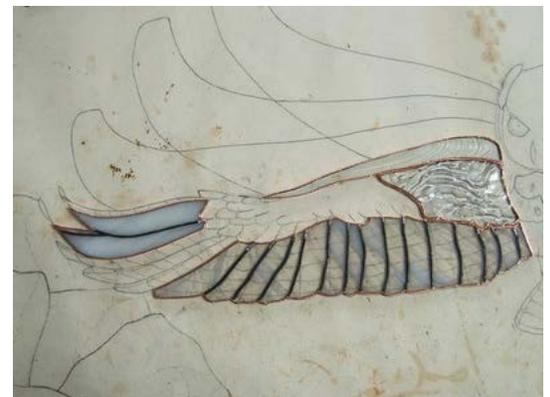
Figure 11: Parts salvaged from top layer of a wing

When the undamaged parts were separated from the broken pieces, the old copper foil was scraped away from the edges with a knife. Then the edges were thoroughly cleaned, the old adhesive was removed, and the pieces were refoiled (figures 11 & 12).

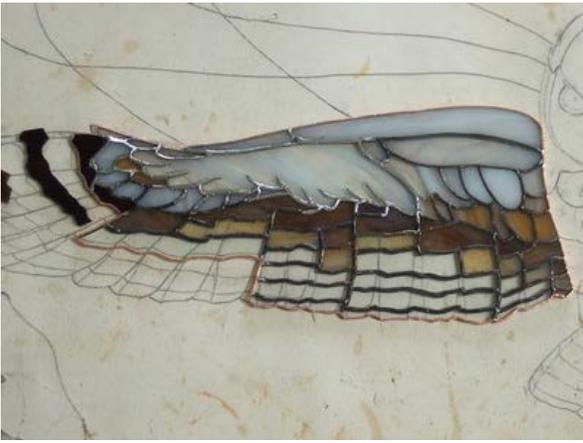
Figure 12: Parts salvaged from the middle layer of wing

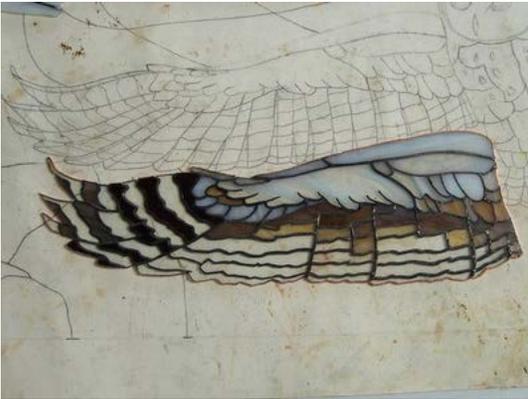
Figure 14: Rebuilt middle layer of wing

I began with the middle of the three layers in the wing (figure 14). This is the most intricate and has all the color. I made new pieces to fit with the old and soldered them together.

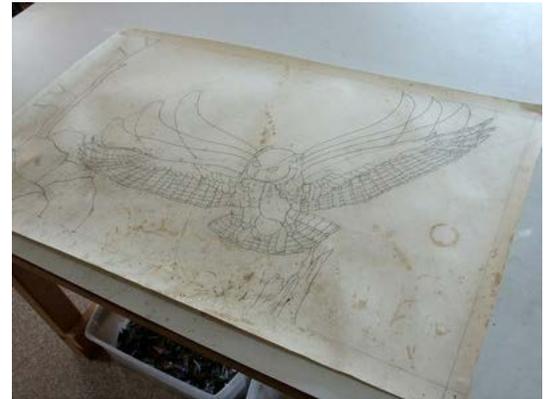
Owl window (figure 13). It was a little the worse for wear, showing historic evidence of the original fabrication that included burns and stains from flux, patina and blood! However, it was usable. I tackled each wing and the bird's head/body separately, as I had when first making it.

Figure 13: The original cartoon

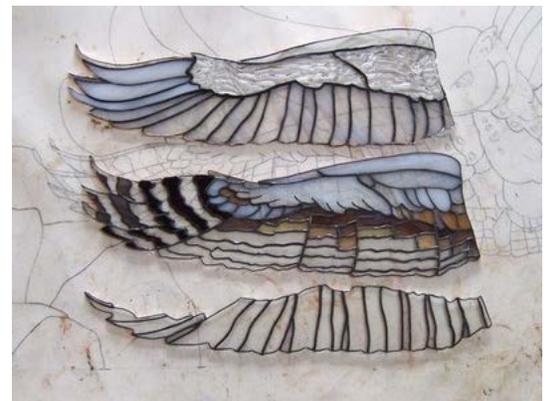
Figure 15: Rebuilt three layers of wing

The other two layers were rebuilt in the same way, with additional care given to making sure that they matched the middle layer closely (figure 15). (This was one aspect of the work

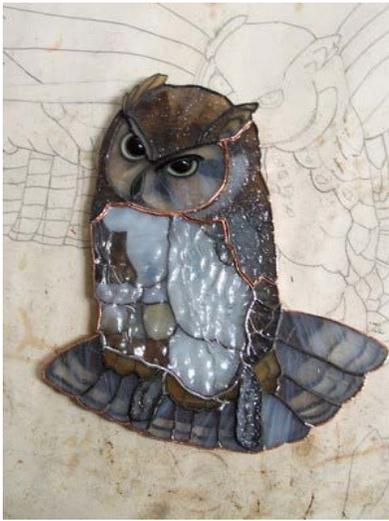
Figure 16: Rebuilding head and body

where my performance has improved over the years!) Each layer was finished, patina'd and cleaned thoroughly, and the three were joined together by tacking around the edges. Finally the wings were attached to the body (figure 16), thus completing the bird (figure 17).

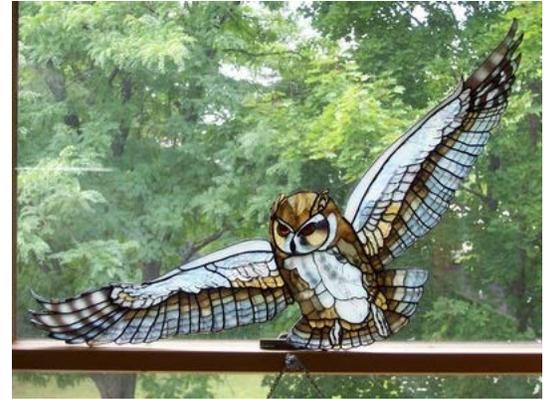
Figure 17: Owl rebuilt

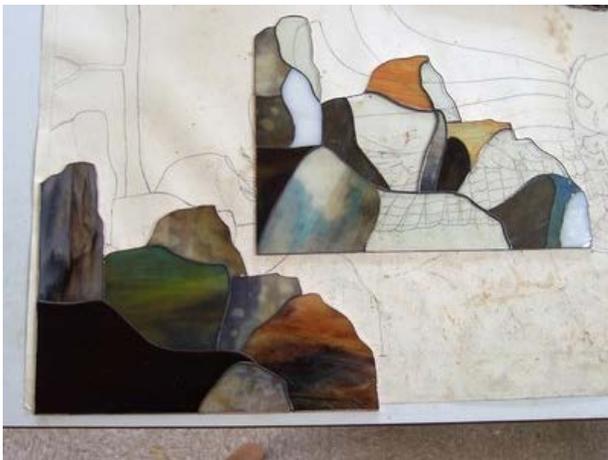
Figure 18: Rocks rebuilt with two layers yet to be joined

The rocks in the lower left corner are made in two layers of glass to give the impression of 3-dimensionality by shading. Some of the glass in the second layer is plain window glass where I did not wish to change the appearance of the front layer glass (figure 18). Several pieces needed to be replaced, and since I could not find exact matches for all of these pieces, the new rocks look slightly different from the original ones. As the original artist I felt free to do this!

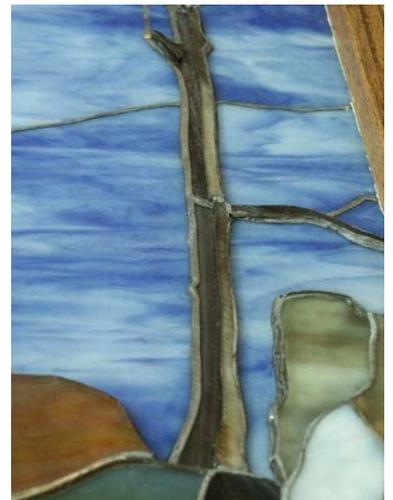
In the original dead tree on the left hand side, the shading effect was

produced by adding a thin strip of light brown glass along the back (figure 19). In the repair, I decided that I could get the same effect more simply by putting a copper foil overlay on the reverse

Figure 19: Tree, reverse side, before repair showing plated shading

side of the tree trunk and branches.

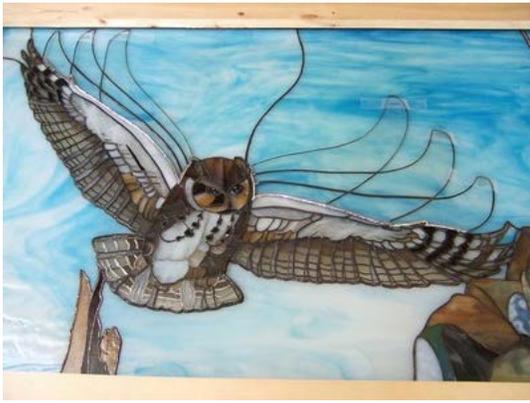
Figure 20: Reverse side of the panel showing phantom wings

The phantom wings are made in plain window glass. These had to be completely rebuilt. They were soldered along the reverse side of the tops of the real wings. The wing tips are glued to the back of the sky glass with tiny dabs of two-part epoxy adhesive. Notice that the copper foil lines get narrower as you go further away from the real wings (figure 20).

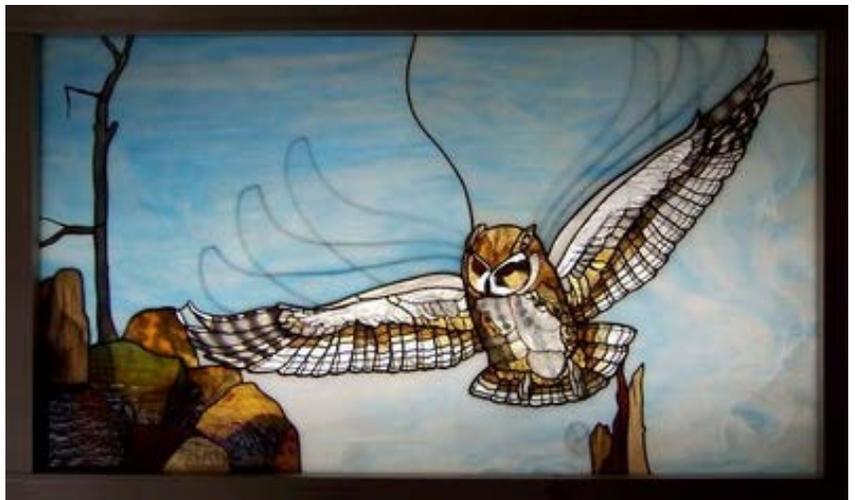
Figure 21: The restored Owl window

Very large pieces are always harder to handle, and I was relatively inexperienced at that time. I was very upset, because it was such a beautiful piece and I knew I would have difficulty finding a similar piece, so I simply foiled the broken pieces and joined them together. In the repair, the line from the owl's tuft to the top of the panel was necessary, because the glass sheets were not wide enough in the direction of the streaks to reach from tree to right wing tip (figure 21).
