Community Benchmarks Program

Accessibility and Distribution of Centro Bus Shelters

***Accessibility and
Distribution of Centro Bus
Shelters***

Spring 2006

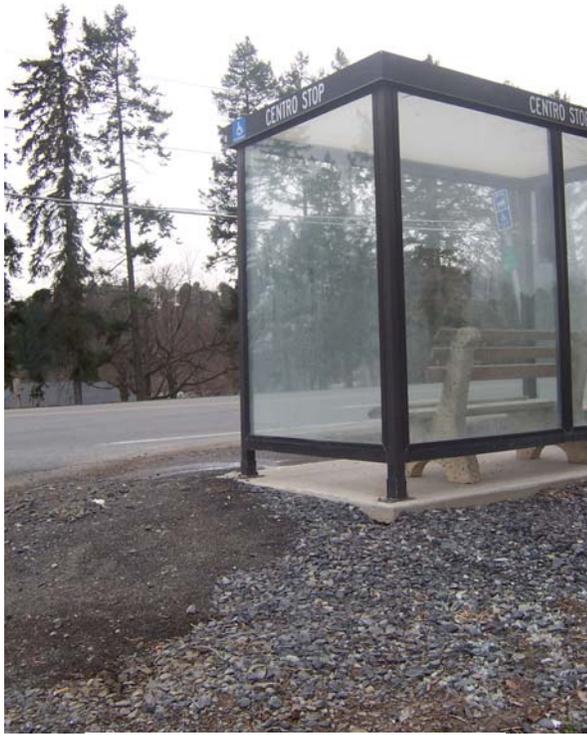
East Genesee and Jewish Center

A curb cut is a gradual incline in the cement used to transition from the street to the sidewalk.

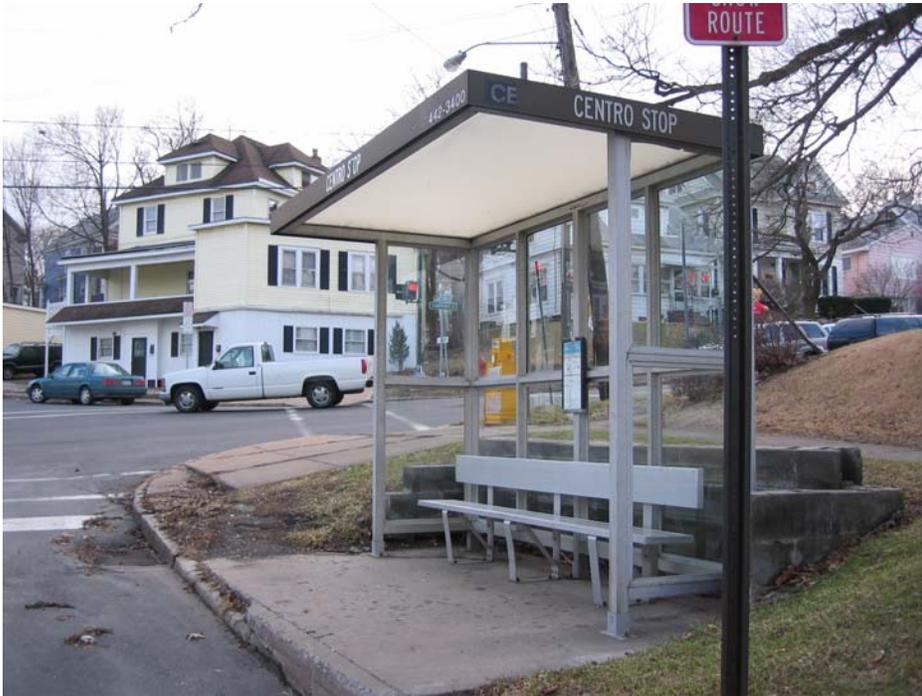
Milton and Tompkins

Shelter floor space less than 30 inches by 48 inches

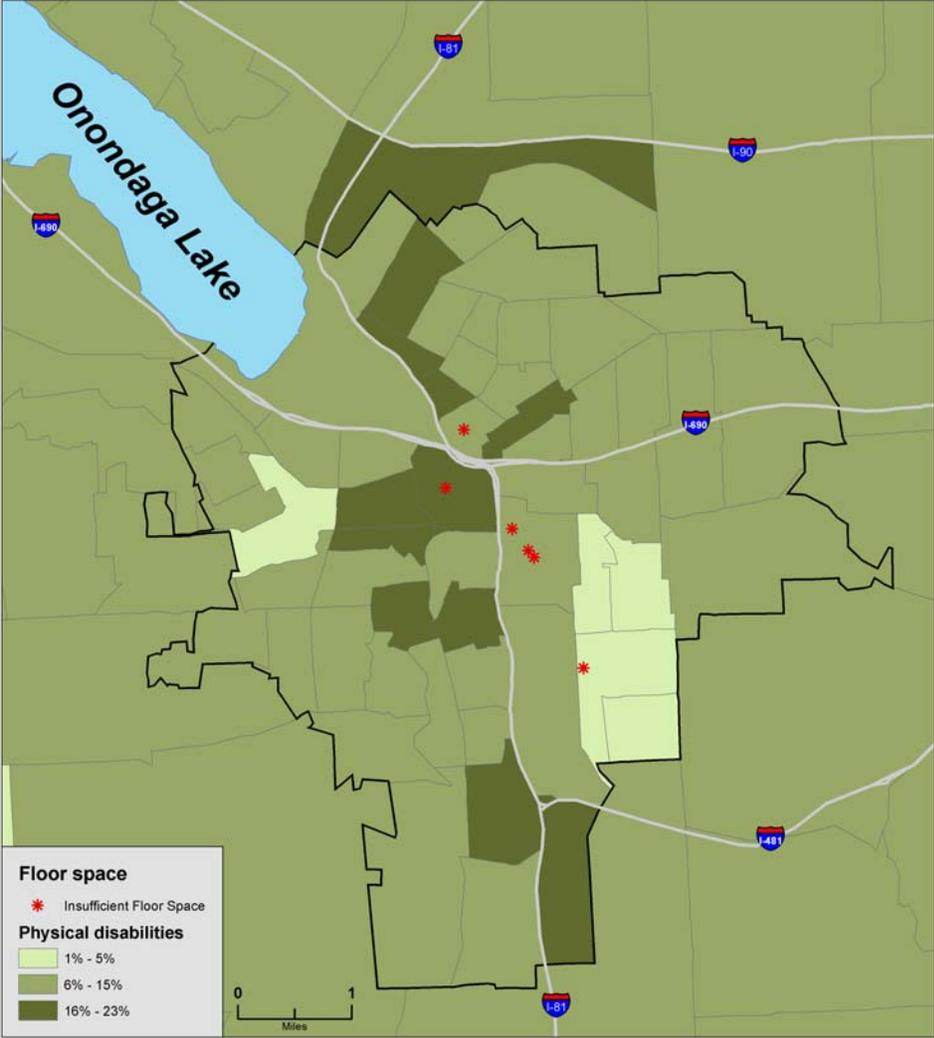
Shelter floor space less than 30 inches by 48 inches and percent of population with physical disabilities (2000 Census)

Disabilities are calculated for the civilian, noninstitutionalized population 5 years and over (2000 US Census)
 Bus shelter assessments were conducted in Spring 2006 by the Community Benchmarks Program
 Map created by the SU Community Geographer
