7th International Building Physics Conference

IBPC2018

Rain-tightness of door sill sealing

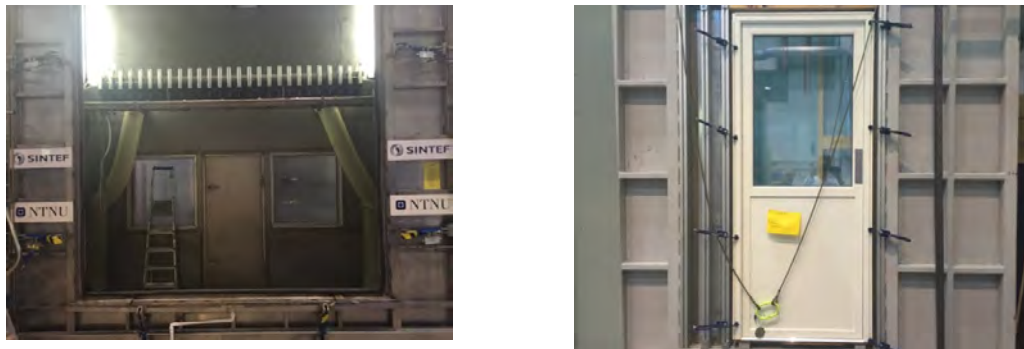
Figure 3. Test equipment for testing according to EN 1027. (left) nozzle system. (right) an example of a door mounted in the apparatus.

The water tightness was tested in accordance with EN 1027 *Windows and doors Water tightness Test method, method 1A – static pressure* (Standard Norge, 2016). The method is designed to determine the water tightness of completely assembled windows and doors. It is also suitable to determine the water tightness of wall sections. Inside the test chamber a controlled static pressure can be applied across the specimen and a nozzle system can apply a continuous regularly dispersed film of water all over the surface of the test section. The water is sprayed by nozzles at an angle of 84° onto the test section at a rate of approximately 2 l/min per nozzle. The test begins with 15 minutes of water application before a static pressure is established over the test section. The water tightness are tested with 5 minute intervals at pressure differences of 50, 100, 150, 200, 250, 300, 450 and 600 Pa. The penetration of water is observed visually during the testing. Location, point in time and pressure is continuously registered during the tests.

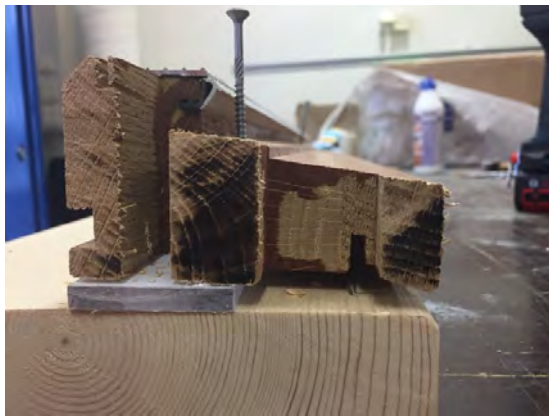
Figure 5. Standard door sill.

Testing of a worst-case scenario with no exterior flashings and gutters gives conservative results. Hence, test specimens were designed by fixing the door sill to a wood sill or a radon membrane with three different joint heights, see Figure 4, 5 and 6. Six of the specimens were designed with a radon membrane between the door sill and the wood sill. A foam gasket was positioned into the joint as a backing material for the compound sealant. The joint was then sealed with silicon compound exterior to the gasket. The sealing of the test samples were carried out as close to a real-life situation for application as possible. The test specimens were positioned on the floor when applying the silicon compound.

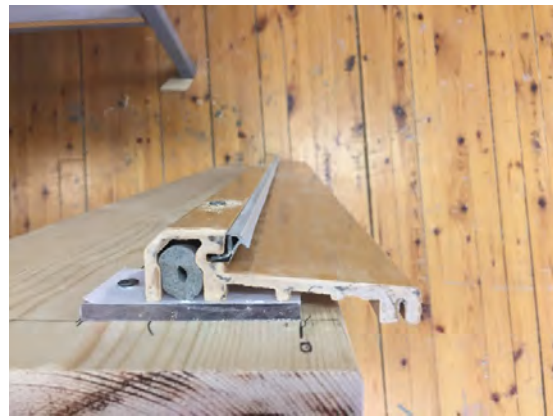
Figure 6. Handicap door sill.

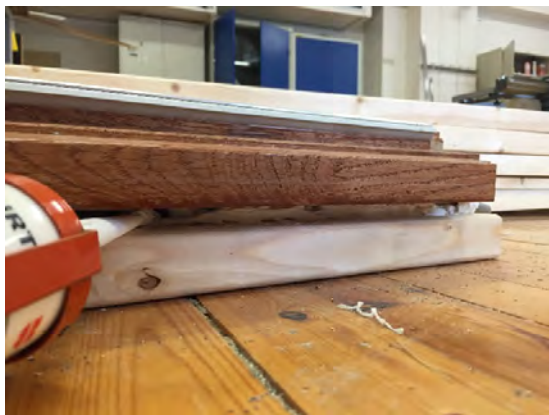
Figure 7. Application of silicon compound.

Challenges related to the workmanship of the application of the silicon compound was encountered even in a controlled laboratory environment and when carried out by qualified craftsmen. When applying the sealing compound as carefully as possible (see Figure 7), small faults were found by close inspection, as seen in Figure 8.

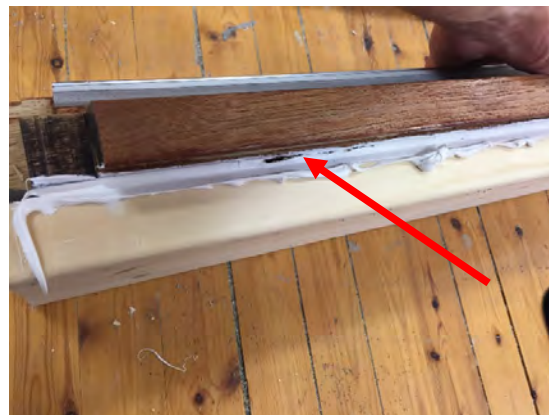
Figure 8. Small defects in the silicon compound was found by closer inspection.

The workmanship of the sealing of the joint was challenging due to the geometry of the detail. Even if the silicon sealant was carefully applied, voids between the silicon sealant and the door sill were found when inspecting closely. When improving the faults, the test showed that the joints were surprisingly tight. Most of the tests showed no water leakages at 600 Pa pressure difference. According to the SINTEF Building Research design guidelines this is *high performance*. However, leakages were observed at lower pressure difference for the sills with no silicon sealing and at faults in the silicon sealing. This indicates that the detail is vulnerable and that great care should be taken when applying the silicon sealant. The performance of the sealed joint is depending on the workmanship of the craftsmen. In order to further improve the robustness of the detail there is a need to introduce sealing methods which ensure high performance more independently of workmanship.
