Jennifer Angel-Amaya¹

¹Corporación Geopatrimonio, www.geopatrimonio.org

In Choco, **artisanal gold mining** has taken place for centuries. However, since 2009, with the rise in gold prices, alluvial mining has been **mechanized**, causing social and environmental devastation.

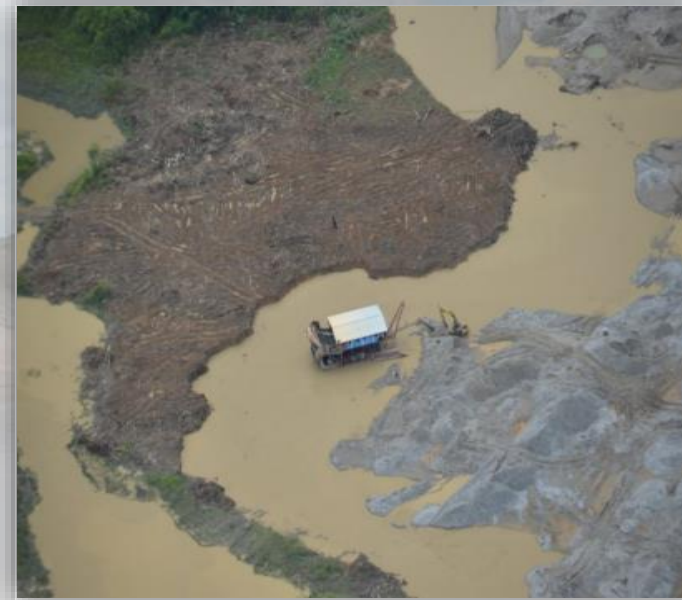
Figure 2. Gold mining in the Atrato river - Choco by using dredges and adding mercury. Source: [1].
