Retrospective Analysis of Hydrologic Performance of Green Infrastructure Systems of the Save The Rain (STR) Program in Syracuse, New York

Priyanka Rajashekar
Syracuse University

Thesis

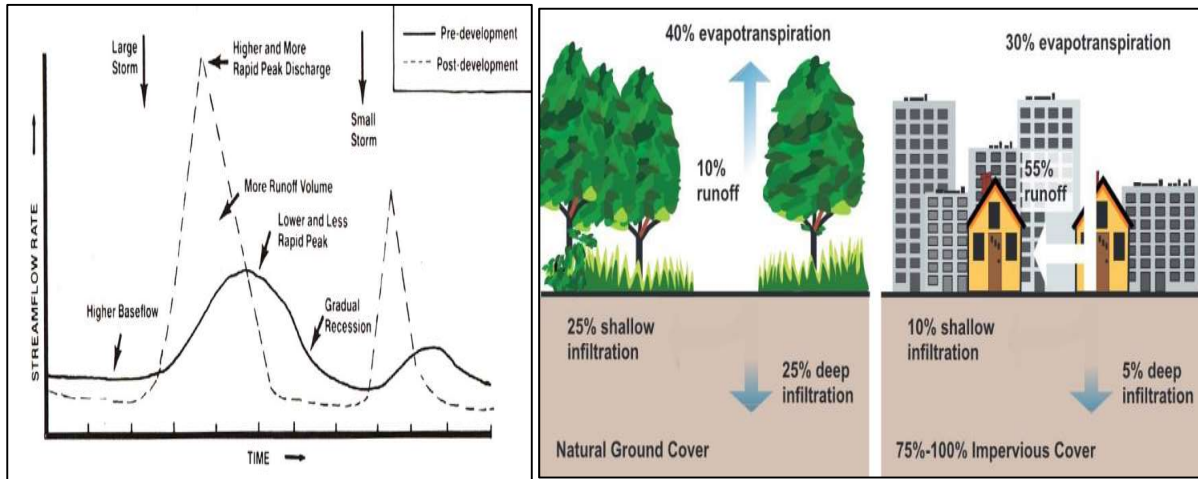
Figure 3: Hydrographs and hydrology of pre- and post-development conditions (USDA)

Thus, the increased impermeable surfaces no longer allow rainfall to infiltrate into the ground and, as a result, generate large volumes of runoff (Figure 3).

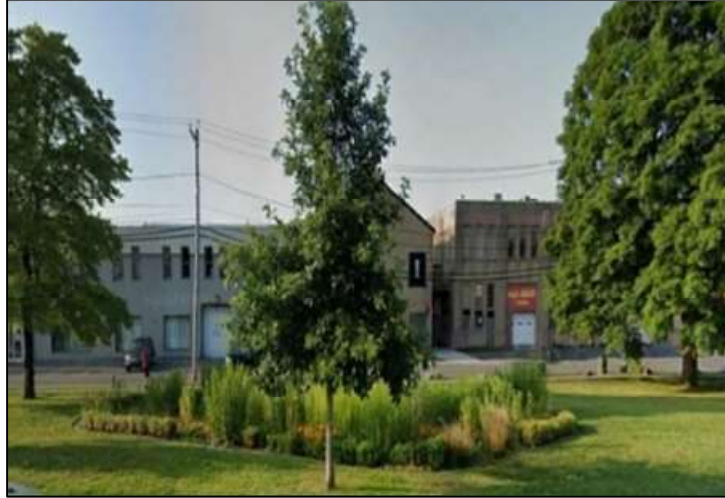
Figure 7: Barker Park rain garden

The Barker Park rain garden captures stormwater runoff from Barker Avenue, Wilkinson, and Tracy streets. It has a surface area of 132 m², impervious cover is 22% and a catchment area of 4908 m². The GI area to total impervious area ratio is 0.12. The excess runoff infiltrated through the GI is drained into the combined sewer system located on Wilkinson Street via the domed outlet riser structure. (Design drawing - Appendix-A, Figure A-1)

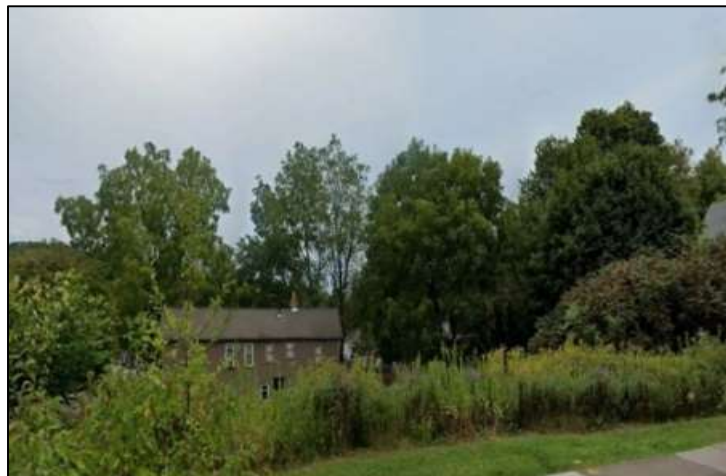
Figure 8: 1344 W. Onondaga vacant lot rain garden

The rain on the vacant lot receives stormwater runoff from the impervious West Onondaga Street and the vacant lot itself. It has a surface retention area of 148 m², with a catchment area of 1885 m² and an impervious area of 87 m². The ratio of the GI area to the total capture area is 1.71. (Design drawing - Appendix-A, Figure A-3)

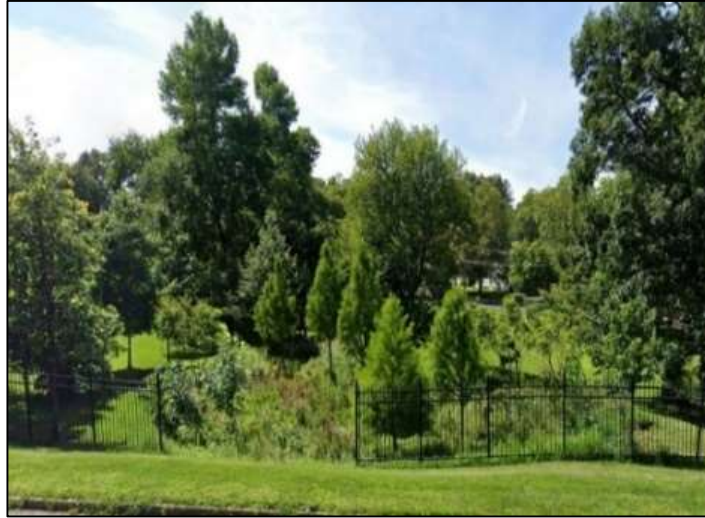
Figure 9: Pass Arboretum North rain garden

The site collects surface runoff from Avery Avenue, Tennyson Avenue, the outflow from the rain garden on the south side, and the precipitation falling directly on it. It has a surface area of 292 m², with a catchment area of 4676 m². It has an impervious cover of 12%. The ratio of the GI area to the capture area is 0.53. This green infrastructure's outlet pipe is connected to a combined sewer system located on South Avery Avenue. (Design drawing - Appendix-A, Figure A-2)

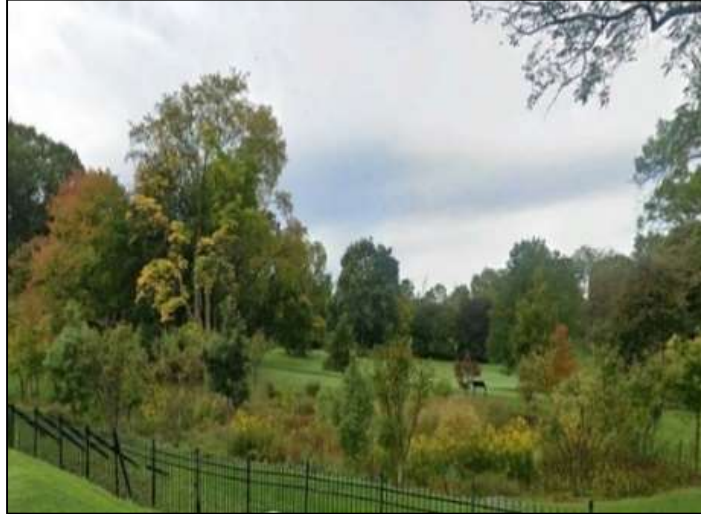
Figure 10: Pass Arboretum south rain garden

The inflows to this rain garden are the surface runoff from Avery Avenue and Bryant Street and direct precipitation. The site surface area is 613 m², with a catchment area of 6451 m², including an impervious area of 1142 m². The ratio of the GI area to the capture area is 0.54. (Design drawing - Appendix-A, Figure A-2)

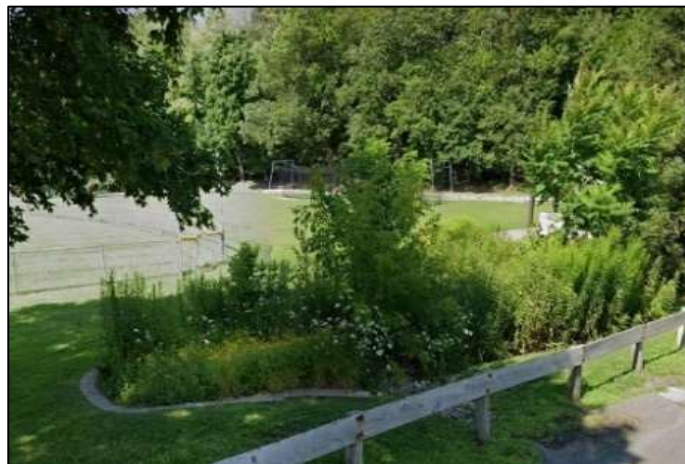
Figure 11: Wadsworth south rain garden

The rain garden receives stormwater runoff from Glenwood Avenue. It has a surface area of 106 m², with a catchment area of 2241 m² and an impervious cover of 24%. The ratio of the GI

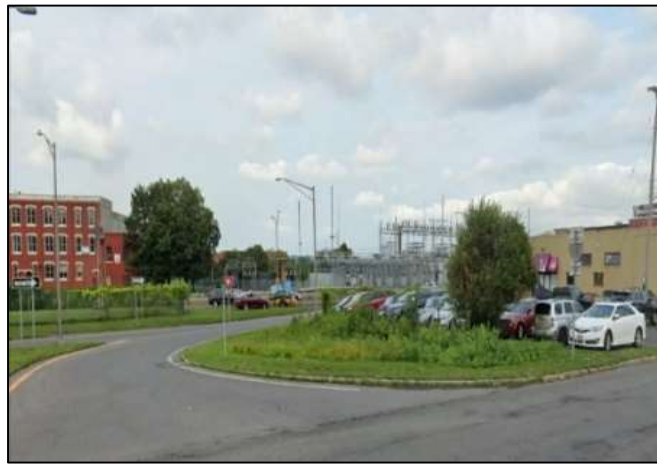
Figure 12: City parking lot 4 rain garden

A rain garden of a surface area of 134 m² is installed to capture stormwater runoff from the I-81 NB ramp and portions of N. State Street. The catchment area is 3067 m². The total fraction of impervious cover is 82%. The ratio of the GI area to the capture area is 0.05. The rain garden receives runoff from the porous City Lot 4, from an 80' by 5' roadside infiltration trench, and a curbside stormwater inlet. The site drains excess runoff into a storm drain located on N. State St. (Design drawing - Appendix-A, Figure A-6)

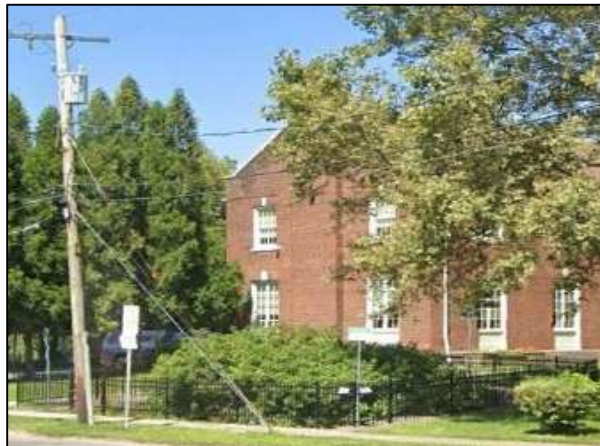
Figure 14: White library infiltration trench

The infiltration trench collects runoff from Peters Street and the impervious parking facility. It has a surface area of 52 m² and a catchment area of 986 m², resulting in a GI area to capture area ratio of 0.06. (Design drawing - Appendix-A, Figure A-7)

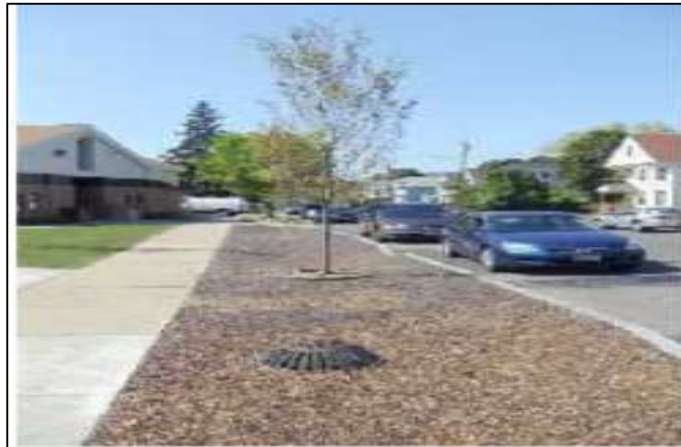
Figure 16: Mundy library infiltration trench

The infiltration trench installed along Rowland Street diverts street surface runoff to the curbside stormwater drains. The trench capture area is 59 m². The total catchment area is 1136

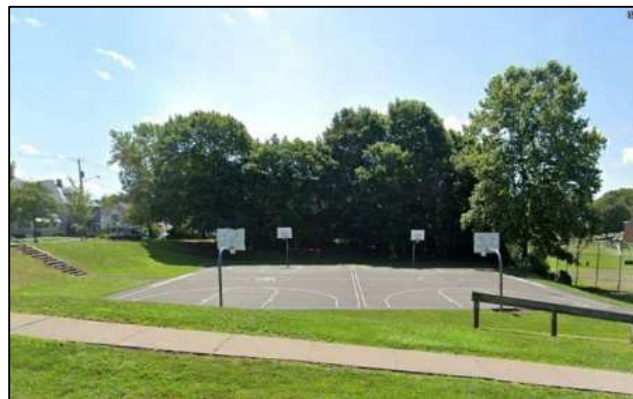
Figure 18: Lewis Basketball Court permeable pavement

Lewis Basketball Court is constructed of porous asphalt collects stormwater runoff from Lewis Street to the north, Milton Ave to the east, walkways within the park, and the court itself. The excess flow is directed to the combined sewer system located on Lewis Street. It has a surface area of 819 m² and a catchment area of 2762 m². The percentage of impervious cover is 31.1. The ratio of GI to capture area is 0.95. (Design drawing - Appendix-A, Figure A-10)

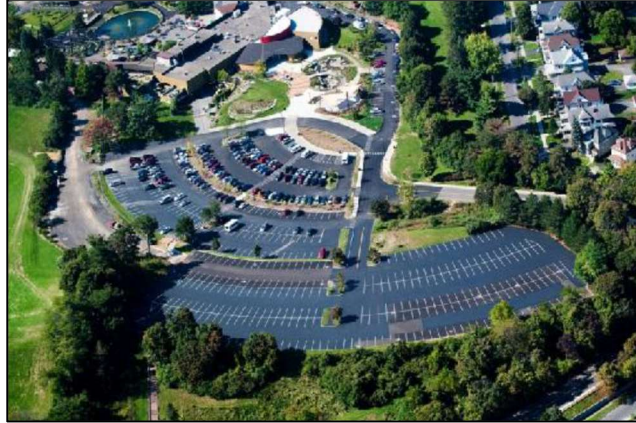
Figure 19: Zoo elephant parking lot permeable pavement

The zoo has a porous asphalt parking lot on the northeast side. The permeable pavement captures runoff from the 2/3rd of the parking lot. It has a surface area of 1222 m². The catchment area is 610,577 m², and the percentage of impervious area is 80.0. The ratio of GI to capture area is 0.25. The excess flow is drained into combined sewer systems. (Design drawing - Appendix-A, Figure A-11)

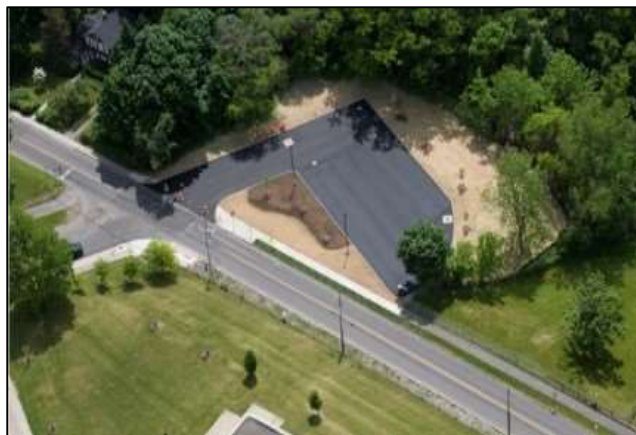
Figure 20: Hughes Magnet School parking lot permeable pavement

The new parking facility constructed from porous asphalt captures surface runoff from the existing adjacent parking lot, school roof, Jamesville Ave, and the parking lot itself. It has a

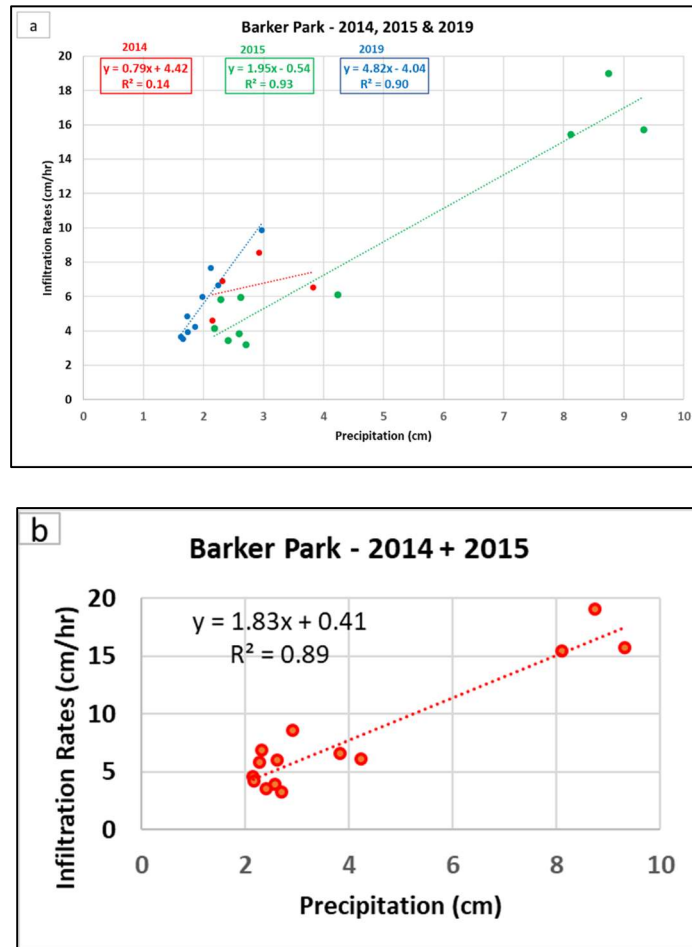
Figure 26: Regression analysis charts for Barker Park rain garden

(Figure 26a). Similarly, the aggregated data for 2014-2015 also shows a strong positive trend (Figure 26b)

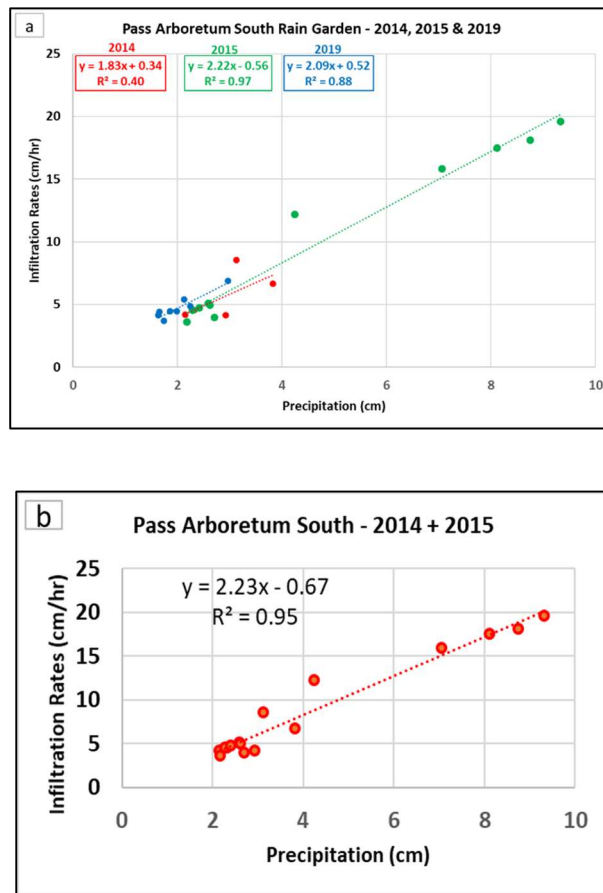
Figure 27: Regression analysis charts for Pass Arboretum south rain garden

Pass Arboretum south rain garden showed response to precipitation on 5 days in 2014 with a range of 2.15 – 3.83 cm, 11 days in 2015 with a range of 2.09 – 9.33 cm and 9 days in 2019 with a range of 1.63 – 2.97 cm. The corresponding infiltration rates ranged from 4.12 to 8.5 cm/hr in 2014, 3.61 to 19.59 cm/hr in 2015, and 3.68 to 6.84 cm/hr in 2019. The 2014 records (red) show a weak trend, but the 2015 (green) and 2019 (blue) show a strong positive trend (Figure 27a). Similarly, the aggregated data for 2014-2015 also shows a strong positive trend (Figure 27b)

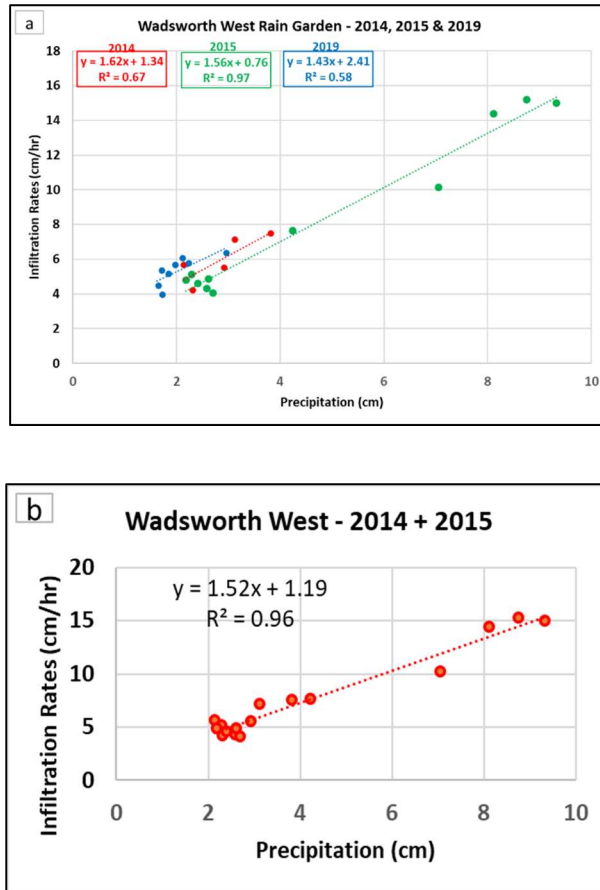
Figure 28: Regression analysis charts for Wadsworth west rain garden

Wadsworth west rain garden showed response to precipitation on 5 days in 2014 with a range of 2.15 – 3.83 cm, 11 days in 2015 with a range of 2.09 – 9.33 cm and 8 days in 2019 with a range of 1.66 – 2.97 cm. The corresponding infiltration rates ranged from 4.2 to 7.48 cm/hr in 2014, 4.05 to 15.2 cm/hr in 2015, and 3.95 to 6.32 cm/hr in 2019. The 2014 records (red) and 2019 records (blue) show moderate identical trends, but the 2015 (green) shows a strong positive trend (Figure 28a). However, the aggregated data for 2014-2015 also shows a strong positive trend (Figure 28b)

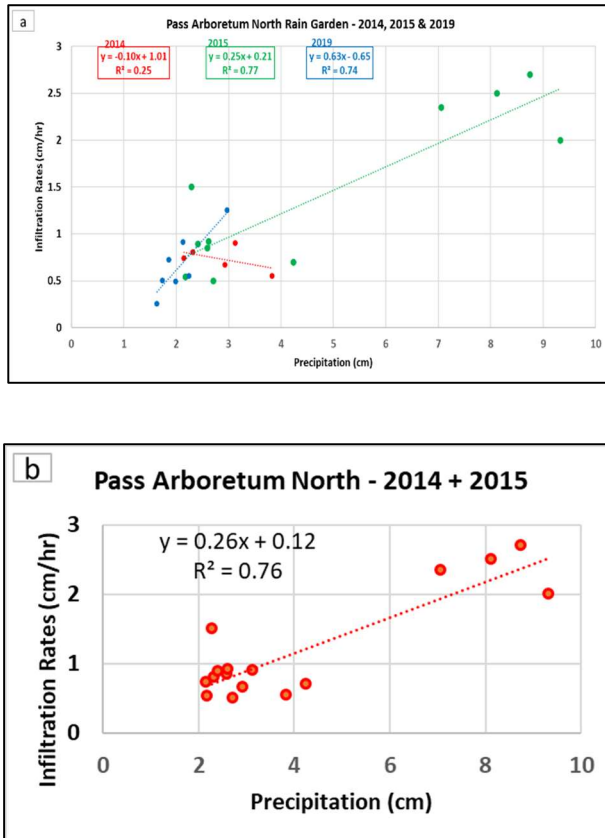
Figure 29.: Regression analysis charts for Pass Arboretum north rain garden

Pass Arboretum north rain garden showed response to precipitation on 5 days in 2014 with a range of 2.15 – 3.83 cm, 11 days in 2015 with a range of 2.09 – 9.33 cm and 7 days in 2019 with a range of 1.66 – 2.97 cm. The corresponding infiltration rates ranged from 0.55 to 0.9 cm/hr in 2014, 0.5 to 2.7 cm/hr in 2015, and 0.17 to 1.25 cm/hr in 2019. The 2014 records (red) show a weak decreasing trend, but the 2015 (green) and 2019 (blue) records show a strong increasing trend (Figure 29a). The aggregated data for 2014-2015 also shows a similar strong positive trend (Figure 29b)

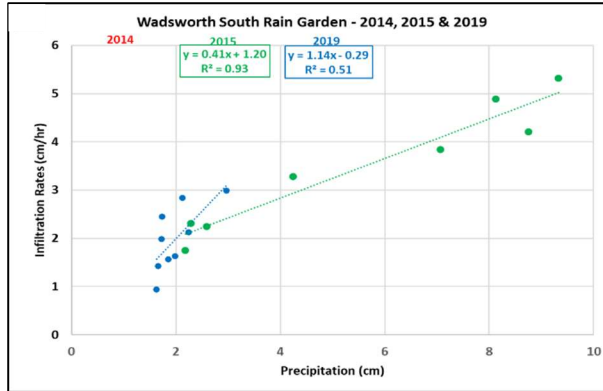
Figure 30.: Regression analysis charts for Wadsworth south rain garden

Wadsworth south rain garden showed response to precipitation on 8 days in 2015 with a range of 2.09 – 9.33 cm and 9 days in 2019 with a range of 1.66 - 2.97 cm. The corresponding infiltration rates ranged from 1.75 to 5.32 cm/hr in 2015 and 0.93 to 2.98 cm/hr in 2019. There was no data for this site for 2014. The 2015 records (green) show a strong increasing trend whereas 2019 records (blue) show a moderate increasing trend (Figure 30).

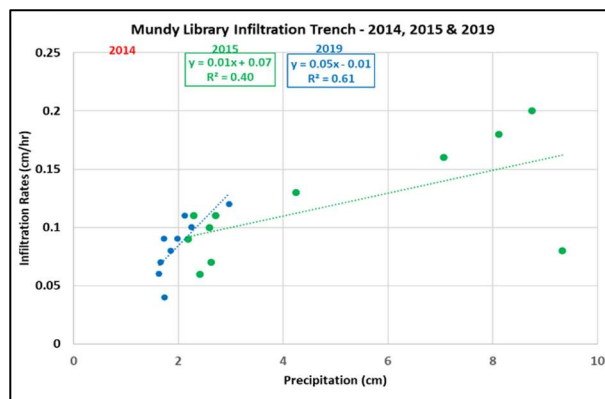
Figure 33: Regression analysis charts for Mundy library infiltration trench

Mundy Library infiltration trench showed response to precipitation on 11 days in 2015 with a range of 2.18 – 9.33 cm, and 9 days in 2019 with a range of 1.66 - 2.97 cm. The corresponding infiltration rates ranged from 0.06 to 0.2 cm/hr in 2015 and 0.04 to 0.12 cm/hr in 2019. This site was not monitored in 2014. The 2015 (green) and 2019 records (blue) show moderate increasing trend (Figure 33).

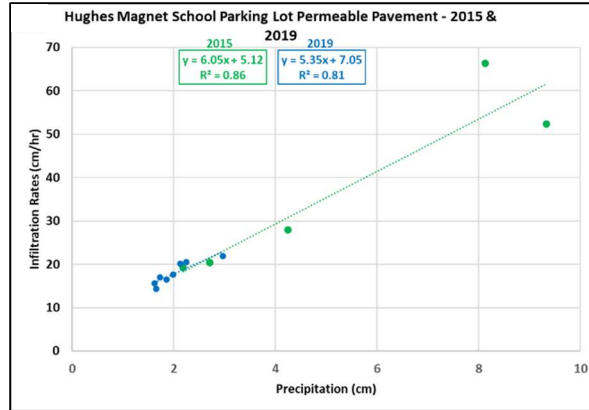
Figure 37: Regression analysis charts for Hughes Magnet School parking lot permeable pavement

Hughes Magnet School permeable pavement showed response to precipitation on 5 days in 2015 with a range of 2.18 – 9.33 cm and 8 days in 2019 with a range of 1.66 - 2.97 cm. The corresponding infiltration rates ranged from 19.25 to 66.40 in 2015 and 14.35 to 21.83 cm/hr in 2019. This site was not monitored in 2014. The 2015 records (green) and 2019 records (blue) show a strong increasing trend (Figure 37).

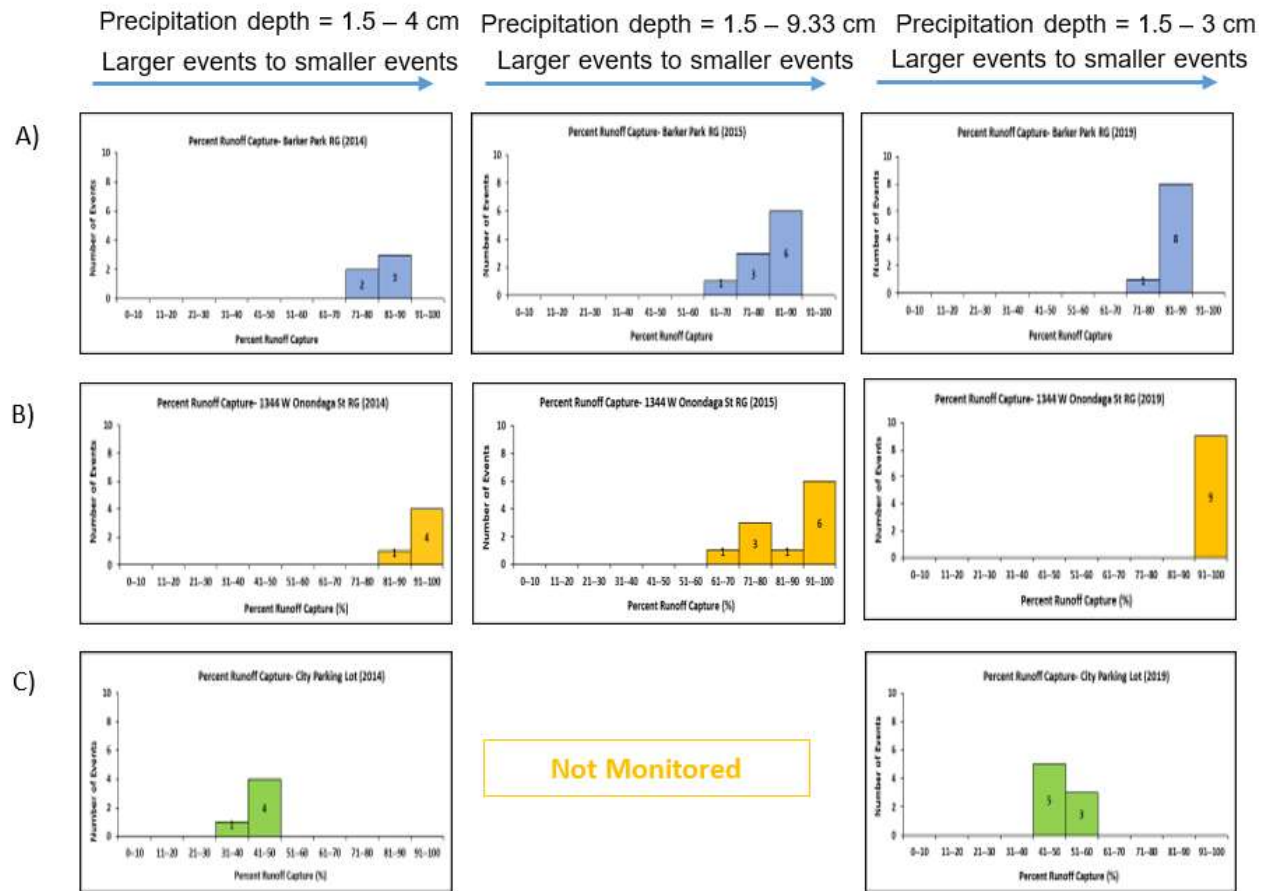
Figure 39: Frequency-analyses plots for percent runoff capture A) Barker Park rain garden B) 1344 W Onondaga St. rain garden C) City parking lot 4 rain garden.

The rain garden on the W. Onondaga street shows the highest percent runoff capture among the three rain gardens and this may be attributed to its larger plan area and lower ratio of impervious to GI area. Also, from the recession limbs on the hydrographs, it can be observed that the W. Onondaga lot rain garden has shorter recession times and greater soil storage depth, whereas the city Parking lot 4 rain garden shows slower recession. This may explain the greater storage capacity for runoff capture at W. Onondaga lot rain garden when compared to the City Parking lot that has reduced storage capacity.
