7th International Building Physics Conference

Campus as a Lab for Computer Vision-based Heat Mapping Drones: A Case Study for Multiple Building Envelope Inspection using Unmanned Aerial Systems (UAS)

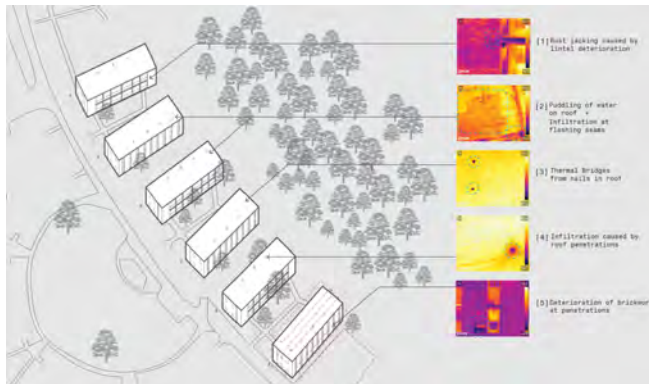
Figure 3. Sample results from building envelope audit.

RESULTS
Building Envelope Audit
The audit flight took place on two separate days, the first day inspected 3 buildings using 3 batteries taking infrared video, and the second flight inspected two buildings taking still pictures, Building D was not fully inspected due to the proximity of trees on the southern façade as well. Each flight date was undertaken in 90 minutes. Figure 3 showcases 5 major categories of audit results that include: Rust – showcased through deterioration in the building façade. Water damage – infiltration and puddling of water on the roof at seams. Thermal bridges – due to faulty construction practice while installing roofs. Penetration – malfunction of envelope integrity (in façades and roofs). Brickwork deterioration – at openings and penetrations in the façade.

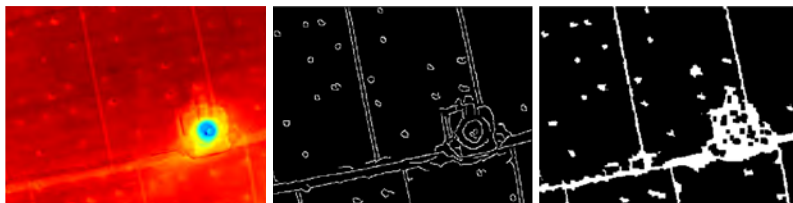
Figure 4. Experimental results from various sides of the inspected buildings. In each triplet, the left are IR scenes, middle are edge detection, and right are the segmented leakage regions.

We tested the developed algorithm on 149 thermal images that contain a total of 1018 heat leakage regions. From these leakage regions, the algorithm successfully detects 751 of them, and missed 267 actual thermal anomaly regions. The workflow also reported 237 regions that are considered false positives. This resulted in precision and recall rates of 76% and 74%, respectively. These rates will increase as the algorithm is further developed to match expert identification of anomalies. Figure 4 highlights a series of sample heat leakage images and their corresponding detection results.

a) Successful infiltration detection.

b) Successful thermal bridge detection.
