The Fall and Rise of “Owl”

Robert Oddy

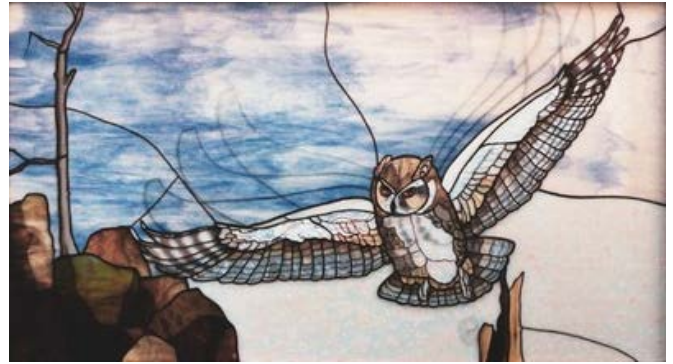
Figure 1: Owl (1988) 22" x 39" stained glass

Robert Oddy, the original window

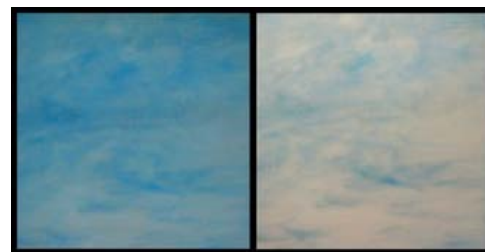
Figure 3: Glass for the sky in daylight (left) and in white fluorescent light (right)

Some of the opalescent glass, particularly in the sky, proved difficult to find. The glass I used in the original in 1988 was not newly manufactured even at that time. One factor in the choice of a replacement was that the window was destined to be installed in a light box, rather than in an exterior window, as it had originally been. I found a satisfactory substitute in a sky-blue and white opalescent by Kokomo. You can see in (figure 3) that this glass is much bluer in daylight. The whites are more prominent, and a little more yellow in white fluorescent light, more like the original glass appeared in daylight. Some of the glass in the rocks, tree and stump is also different from the original. I had no problem finding glass from stock in my studio to match the original glass in the owl's wings and body.

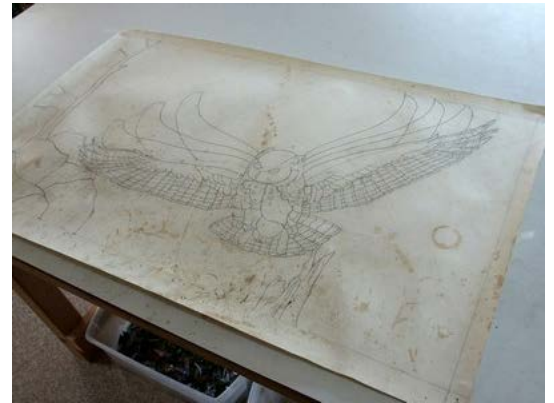
Figure 13: The original cartoon

Owl window (figure 13). It was a little the worse for wear, showing historic evidence of the original fabrication that included burns and stains from flux, patina and blood! However, it was usable. I tackled each wing and the bird's head/body separately, as I had when first making it.

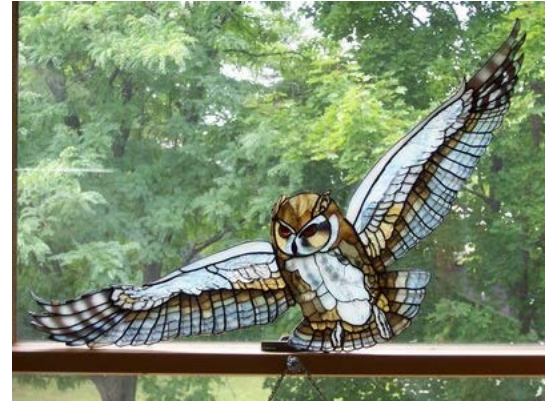
Figure 17: Owl rebuilt

where my performance has improved over the years!) Each layer was finished, patina'd and cleaned thoroughly, and the three were joined together by tacking around the edges. Finally the wings were attached to the body (figure 16), thus completing the bird (figure 17).

As I have already mentioned, the sky had to be rebuilt with a different glass. Originally, the glass above the owl was blue/white and that below the bird was a white mottled glass. I replaced both with the same Kokomo blue/white, using whiter parts of the sheet below the owl.
