# IBPC2018

Healthy, Intelligent and Resilient  
Buildings and Urban Environments

## **Super insulation materials in the building sector: Field studies and future challenges**

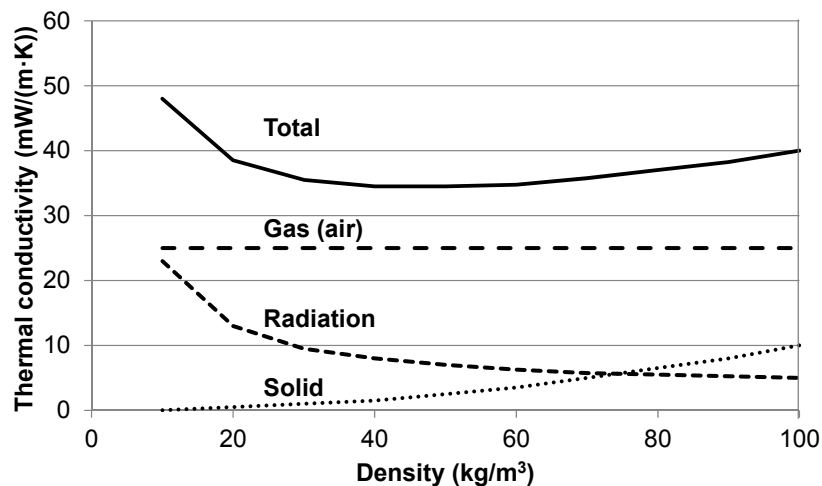
Figure 1. Thermal conductivity in porous materials divided into the three main heat transfer mechanisms (adapted from (Simmler et al., 2005)).

Conventional insulation materials use entrapped air as insulator inside a porous matter. Examples of these are mineral wool, expanded polystyrene and polyurethane. By using different additives, the thermal conductivity can be reduced by targeting the three main heat transfer mechanisms presented in Figure 1 (Berge & Johansson, 2012).

The total thermal conduction can be reduced down to a minimum around 30 mW/(m·K), which can be compared to stagnant air which has 25 mW/(m·K). Therefore, in this paper SIMs are defined as materials having a thermal conductivity lower than stagnant air ( $\lambda = 25 \text{ mW/(m·K)}$ ). To reduce the thermal conductivity further, the heat transfer through the gas has to be reduced. This can be achieved by a) hindering the gas movements in the pores by reducing the pore size, b) removing the gas, or c) a combination of both a) and b) (Berge & Johansson, 2012).

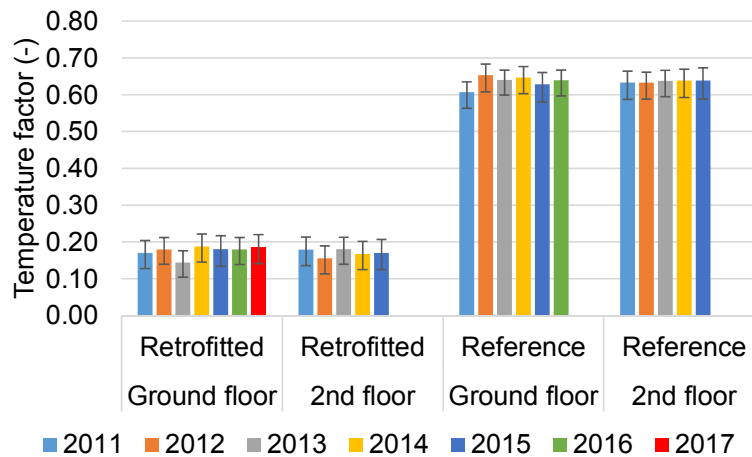
Figure 4. The temperature factor of January 2011 to 2017 for the retrofitted and reference walls. The temperature factor is the percentage temperature decrease over the original wall compared to the total temperature drop over the wall. The error bars show an accuracy of the sensor of  $\pm 0.5^{\circ}\text{C}$  (adapted from (Johansson et al., 2016)).

The external air space made it impossible to identify the different panels by thermography. Only indirect methods, like evaluation of the measured temperatures in the wall, could be used to follow the long-term performance of the panels. For this analysis the average temperature for January each year 2011 to 2017 was used to calculate the temperature factor, see Figure 4. Unfortunately several sensors have been damaged why only one position can be evaluated for all 7 years.

In the reference wall about 64% of the temperature drop was over the uninsulated parts. After the retrofitting only about 17-18% of the temperature drop was over that part of the wall. The results indicate that after 7 years there was no sign of decreased insulation performance of the VIP. The results of this case study after 7 years are in good agreement with also the conclusion from several case studies that were collected in Annex 65 (Adl-Zarrabi & Johansson, 2018).
